# Manhole Inspection Summary

## Manhole # S19CC1002MH

Insp Date: **7/2/07 9:24 AM**

**Location** Address: **2158 JERRY TURNER WAY**

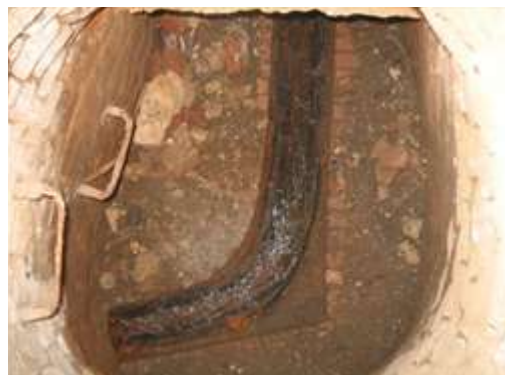
Top View

Corroded steps. Evidence of surcharge - Bench debris.

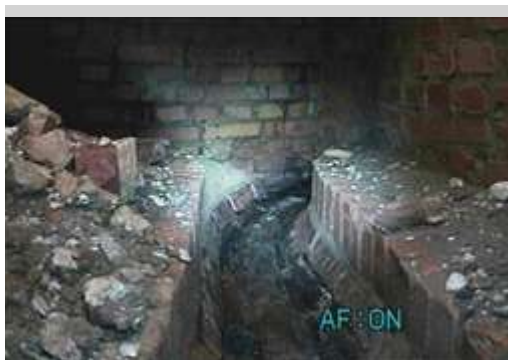
012 View

Offset type one.

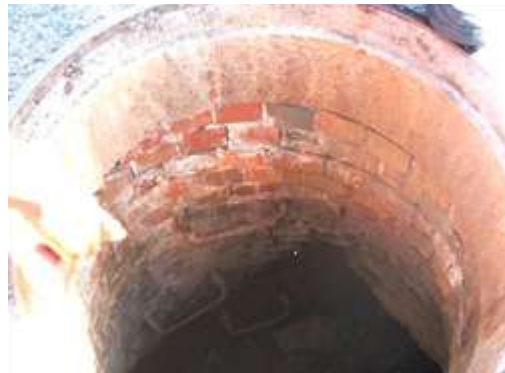
Defect

Condition: ☐ Sound ☐ Cracked ☒ **Leaks**

Condition: ☐ Sound ☐ Cracked ☐ Root Intrusion ☐ Loose Brick ☒ **Deteriorated**

Frame leaks. Adjustment deterioration and infiltration. Corbel and Barrel deterioration and infiltration.

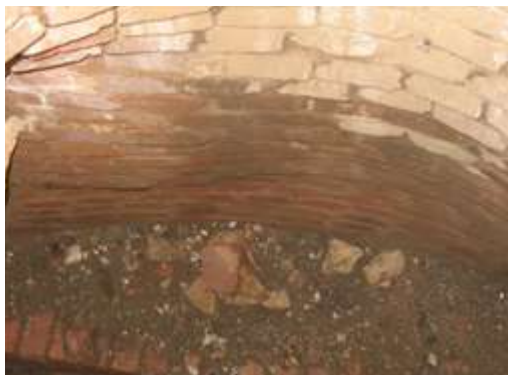
Defect

Corbel and Barrel infiltration.

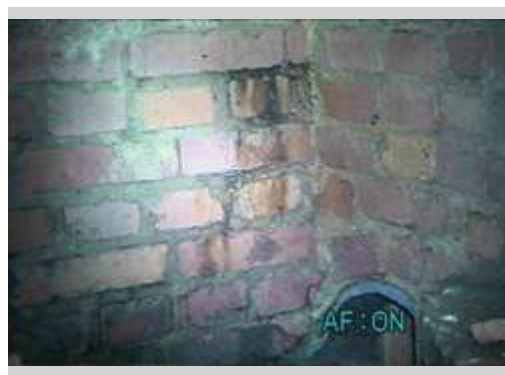
Defect

Barrel infiltration.

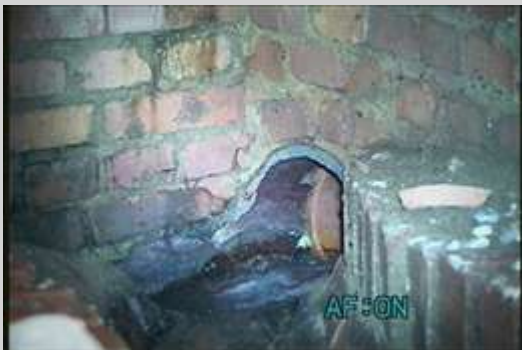
### 8 in. Circular Gravity Sewer Pipe Out @ 12 O'Clock

Infiltration: **Evidence** Pipe Seal Cond: **Unknown**

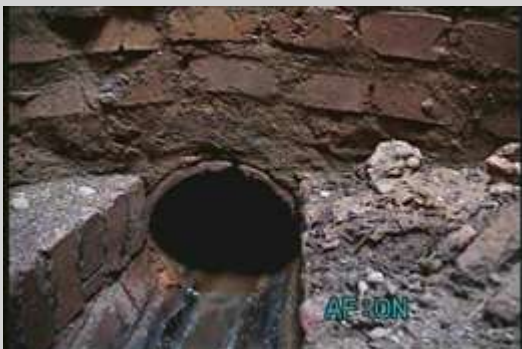
### 8 in. Circular Gravity Sewer Pipe In @ 6 O'Clock

Infiltration: **None** Pipe Seal Cond: **Broken**
